Lessons from the Challenger Launch Decision¹

¹ This case is primarily based on excerpts taken directly from the Rogers' Commission testimony and final Report and has been edited for ease of reading, brevity and clarity. For the complete record and testimony see the full report online at: <http://history.nasa.gov/rogersrep/genindex.htm>

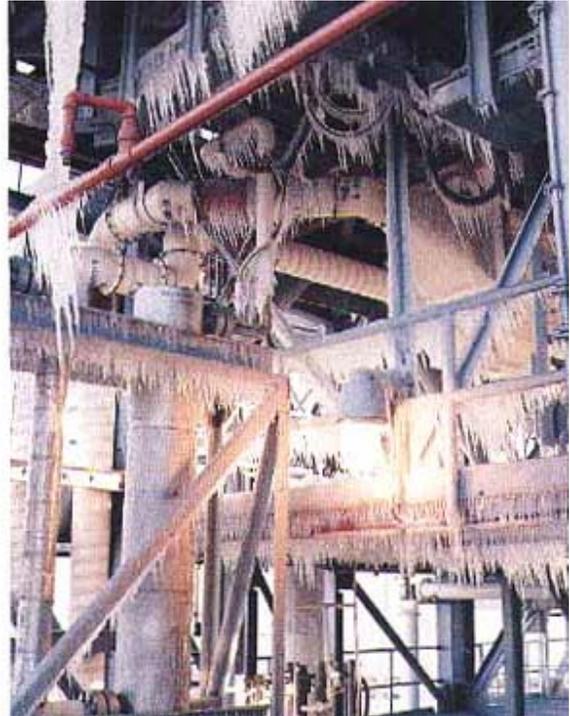
The ambient air temperature at launch was 36 degrees Fahrenheit. This temperature was 15 degrees colder than that of any previous launch.

Figure 2 –Ice on the launch tower hours before the launch.

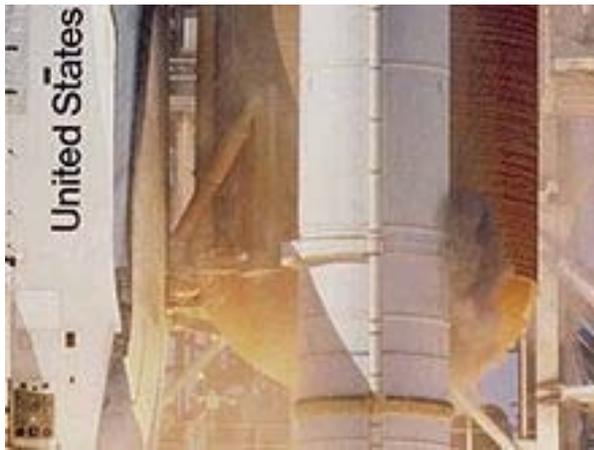
Figure 3- Grey smoke emitting from the right-hand SRB on Space Shuttle Challenger.

Just after liftoff at .678 seconds into the flight, photographic data (Figure 3) show a strong puff of grey smoke was spurting from the vicinity of the aft field joint on the right Solid Rocket Booster. Computer graphic analysis of film from cameras indicated the initial smoke came from the 270 to 310-degree sector of the circumference of the aft field joint of the right Solid Rocket Booster. This area of the solid booster faces the External Tank. The vaporized material streaming from the joint indicated there was not complete sealing action within the joint.

Eight more distinctive puffs of increasingly blacker smoke were recorded between .836 and 2.500 seconds. The smoke appeared to puff upwards from the joint. As the Shuttle increased its upward velocity, it flew past the emerging and expanding smoke puffs. The last smoke was seen above the field joint at 2.733 seconds.

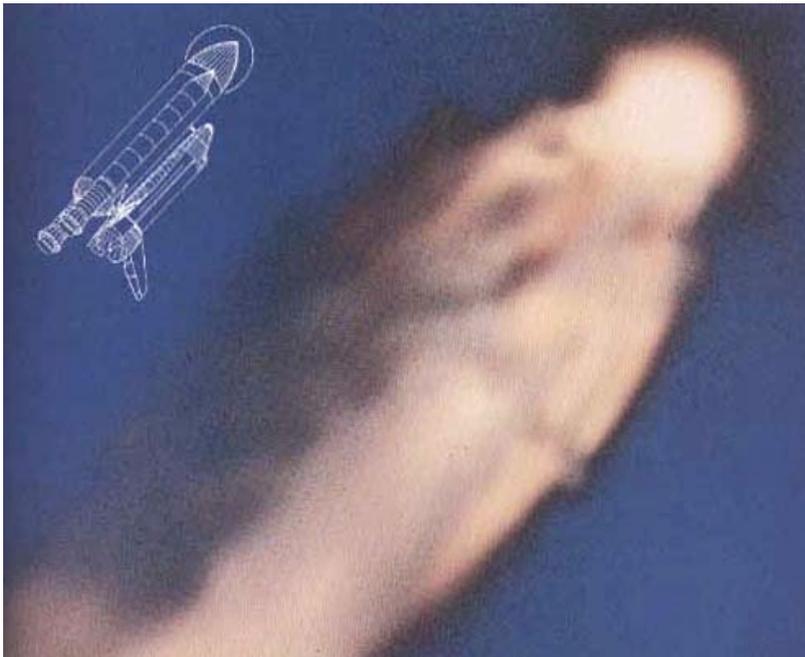
Figure 4 - Rupture of the liquid oxygen tank, which occurred above the booster/tank forward attachment and grew in milliseconds to the maximum size indicated in the computer drawing.

At 73.124 seconds, a circumferential white vapor pattern was observed blooming from the side of the External Tank bottom dome (see Figure 4). This was the beginning of the structural failure of the hydrogen tank that culminated in the entire aft dome dropping away. This released massive amounts of liquid hydrogen from the tank and created a sudden forward thrust of about 2.~3 million pounds, pushing the hydrogen tank upward into the intertank structure. At about the same time, the rotating right Solid Rocket Booster impacted the intertank structure and the lower part of the liquid oxygen tank.

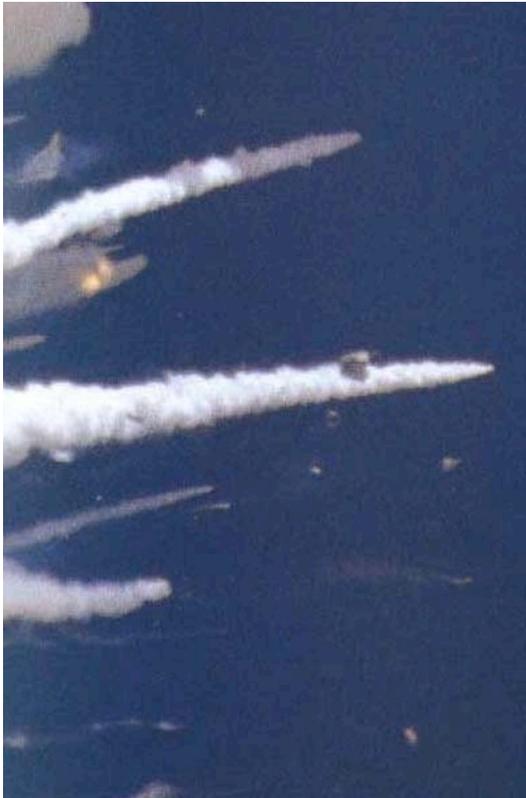
Figure 5 –Large sections of the orbiter emerged from the fireball.

Within milliseconds there was massive, almost explosive, burning of the hydrogen streaming from the failed tank bottom and the liquid oxygen breach in the area of the intertank. The Orbiter, under severe aerodynamic loads, broke into several large sections which emerged from the fireball (Figure 5). Separate sections that can be identified on film include the main engine/tail section with the engines still burning, one wing of the Orbiter, and the forward fuselage trailing a mass of umbilical lines pulled loose from the payload bay. The crew cabin with all the crew inside was found in 100 feet of water on March 8th. They were all still strapped in their seats. Some had activated supplemental oxygen. All would have died when the cabin hit the water at an estimated 200mph if they survived the fall.

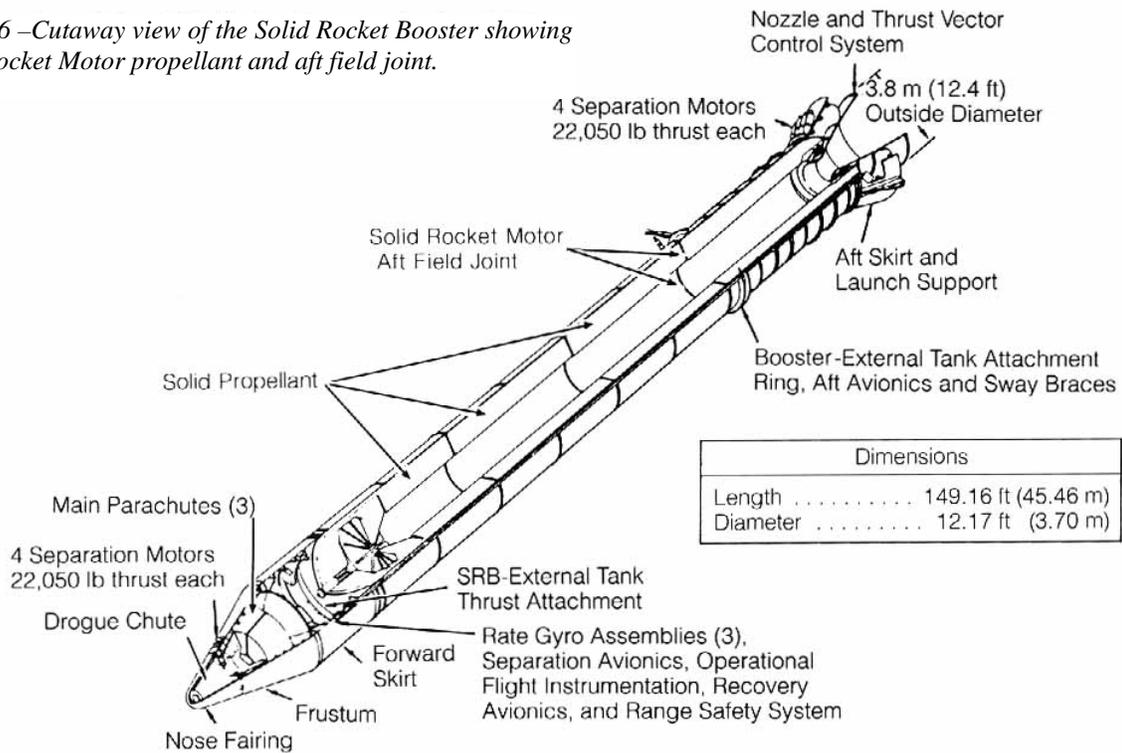
Enhanced photographic and computer-graphic positioning determined that the flame from the right Solid Rocket Booster near the aft field joint emanated at about the 305-degree circumferential position. The smoke at lift off appeared in the same general location. Thus, early in the investigation the right

Solid Rocket Booster aft field joint seal became the prime failure suspect. This supposition was confirmed when the Salvage Team recovered portions of both sides of the aft joint where a hole had burned through that was 28 by 15 inches. Several possible causes could have resulted in this failure.

Figure 6 –Cutaway view of the Solid Rocket Booster showing Solid Rocket Motor propellant and aft field joint.

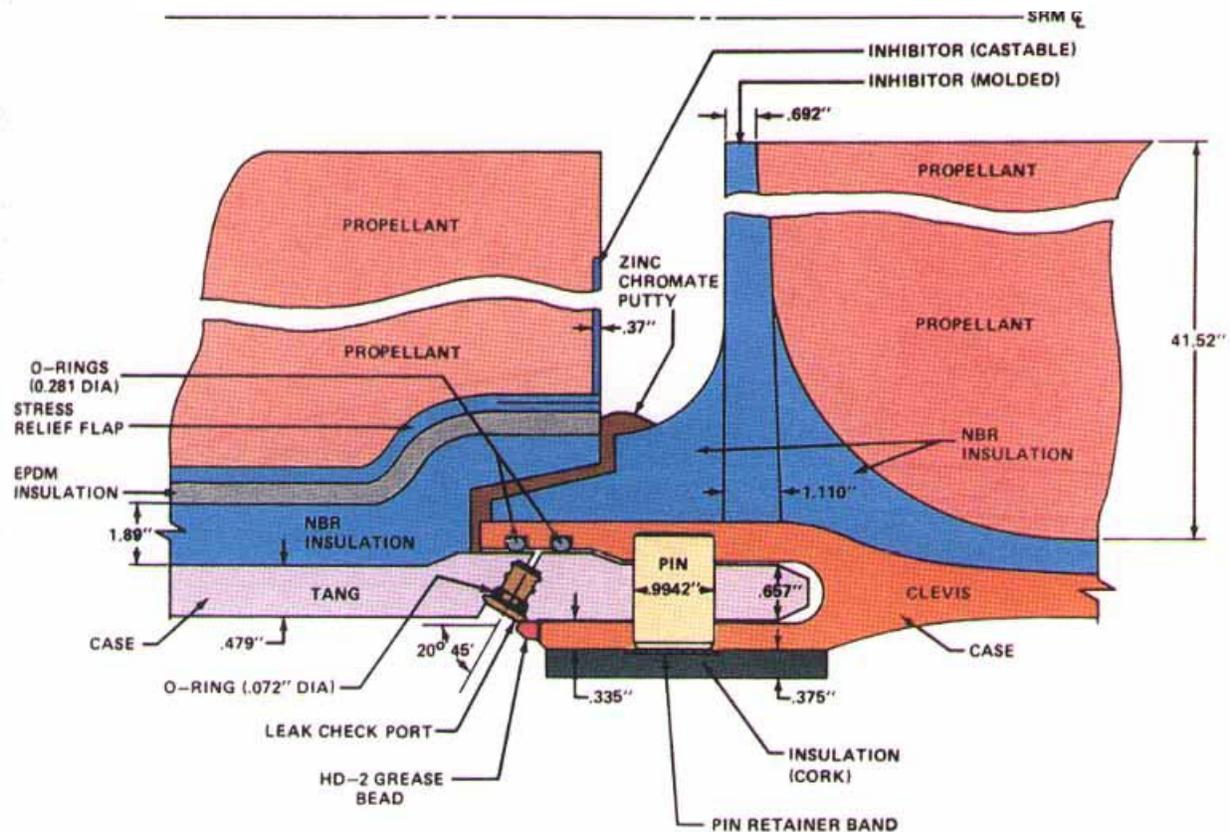
During stacking operations at the launch site, four segments are assembled to form the Solid Rocket Motor. The resulting joints are referred to as field joints. Joint sealing is provided by two rubber O-rings with diameters of 0.280 inches (+0.005, -0.003), which are installed, as received from Morton Thiokol, during motor assembly. O-ring static compression during and after assembly is dictated by the width of the gap between the tang and the inside leg of the clevis. This gap between the tang and clevis at any location after assembly is influenced by the size and shape (concentricity) of the segments as well as the loads on the segments. Zinc chromate putty is applied to the composition rubber (NBR) insulation face prior to assembly. In the assembled configuration the putty was intended to act as a thermal barrier to prevent direct contact of combustion gas with the O-rings. It was also intended that the O-rings be actuated and sealed by combustion gas pressure displacing the putty in the space between the motor segments.

The displacement of the putty would act like a piston and compress the air ahead of the primary O-ring, and force it into the gap between the tang and clevis. This process is known as pressure actuation of the O-ring seal. This pressure actuated sealing is required to occur very early during the Solid Rocket Motor ignition transient because the gap between the tang and

clevis increases as pressure loads are applied to the joint during ignition. Should pressure actuation be delayed to the extent that the gap has opened considerably, the possibility exists that the rocket's combustion gases will blow by the O-ring and damage or destroy the seals. The principal factor influencing the size of the gap opening is motor pressure; but, gap opening is also influenced by external loads and other joint dynamics.

Figure 7 –Aft Segment/Aft Center Segment Field Joint Configuration
