The Pursuit of Images of Columbia

Launch: Impact—“No Apparent Effect...”

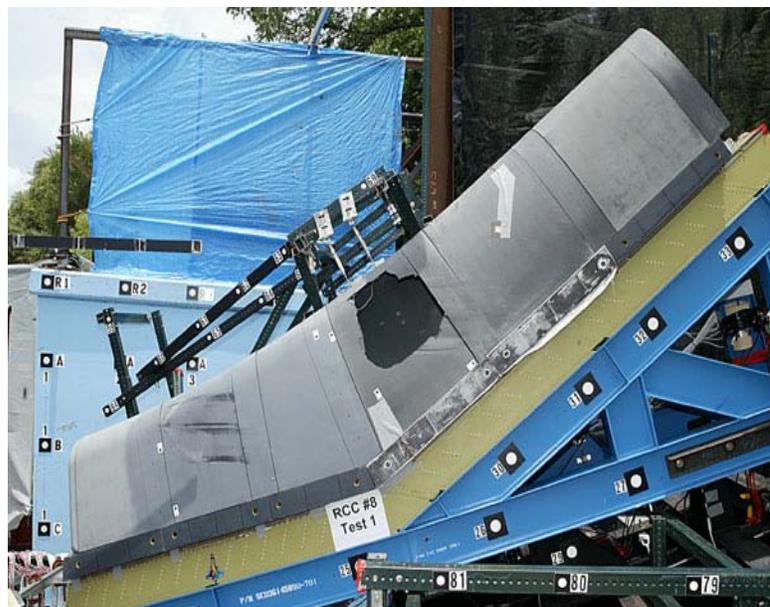
In the aftermath of the accident, heroic efforts were made to recover all possible pieces of debris and to fully understand the cause of the accident. The Columbia Accident Investigation Board (CAIB) tested the impact of foam on various areas of the wing and proved what had been thought unthinkable: foam could indeed compromise the Thermal Protective System. Tests revealed a gaping hole in the RCC panel of the orbiter wing when hit by foam at the relevant speed. The Board concluded that "the physical cause of the loss of Columbia and its crew was a breach in the Thermal Protection System on the leading edge of the left wing, caused by a piece of insulating foam which separated from the left bipod ramp section of the External Tank at 81.7 seconds after launch, and struck the wing in the vicinity of the lower half of Reinforced Carbon-Carbon panel number 8."⁶

Figure 2 - Results from the foam-impact test of the Columbia debris strike. NASA Image
