The Building 5 Flood: The Little Cap that Couldn't

First There Was a Sink

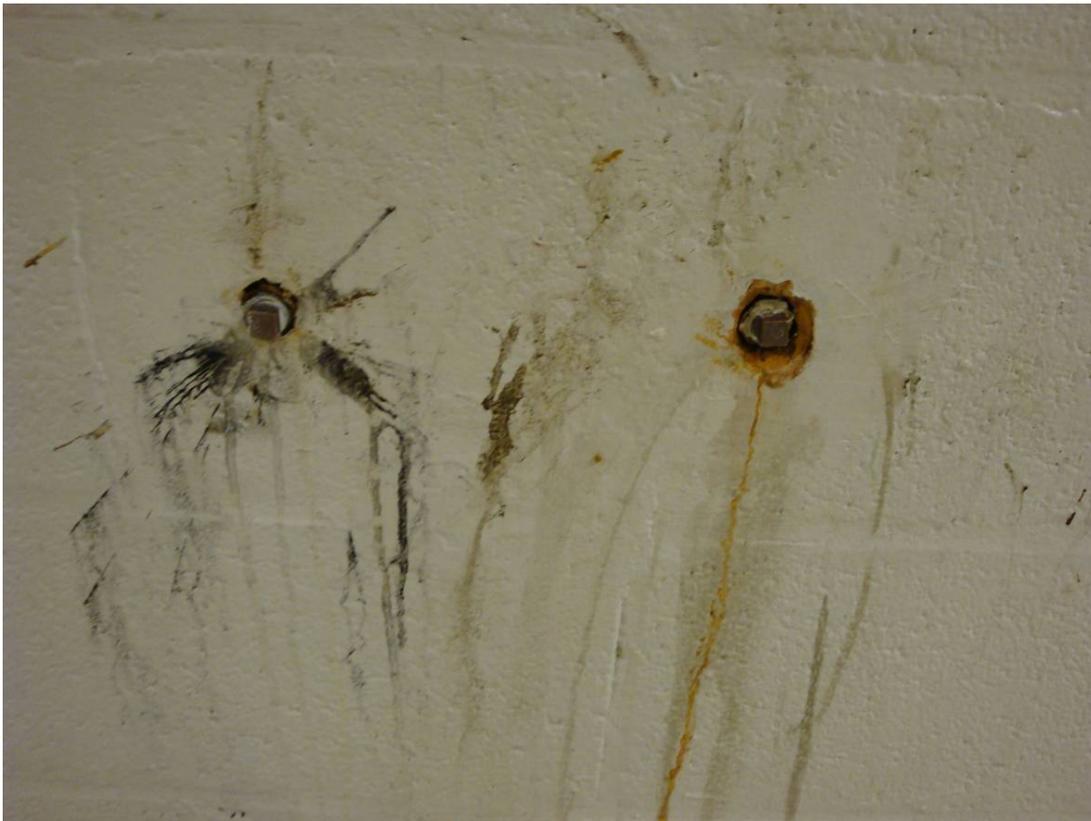
One of those sinks, in the center section, second floor of Building 5, was removed one day, probably sometime in 1976, to make a hallway between the newly configured offices. As the pipes bringing hot and cold water to the sink protruded directly through a cinder-block wall, instead of removing them completely, the pipes were capped off and left sticking out. No records exist of the repair job and no one using that hallway thought much about the little stubs (See **Figure 1**).

No one knows why the steel caps were used, but the pipes and their steel caps held on for over 30 years. During this time, they received as many as 17 coats of paint. This made them a bit less unsightly, but also helped hide the galvanic corrosion going on inside the pipes. The caps did give some clues as to their inevitable fate, dripping and leaking now and then, leaving telltale marks on the walls. These leak stains were also painted over from time to time and the caps were left to the fate of the relentless, slow, self-destructive dance at work where threads of the copper pipes, still under constant water pressure, embraced the little steel caps.

Figure 1: Rust Stains Indicating Imminent Plumbing Failure (Discovered after the Fact). Source: NASA Image.

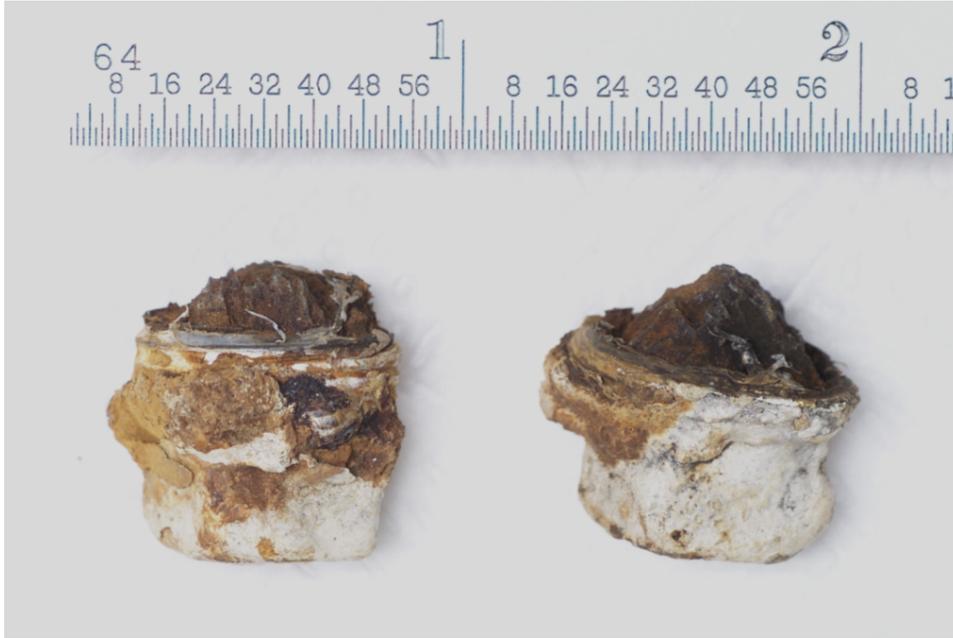
One piece of good fortune that day was the presence at Goddard of a plumber. The plumber arrived shortly after the flood was discovered around 6 a.m., and shut off the water and set about recapping the hot water pipe. While he was capping it, the cold line cap decided it too had had enough. It popped off, joining in the flood. The cold line was quickly shut off, but the damage to Building 5 was already extensive. By Monday morning, dozens of people were without an office to work in, and had to be relocated. The clean-up and investigation both got underway. By the time the reports were written, the total cost was estimated at over \$400,000, because of a few parts likely costing less than \$5 (See **Figures 2** and **3**).

Figure 2: Pipe Plugs Recovered from Building 5 Flood Incident Site. Source: NASA Image.

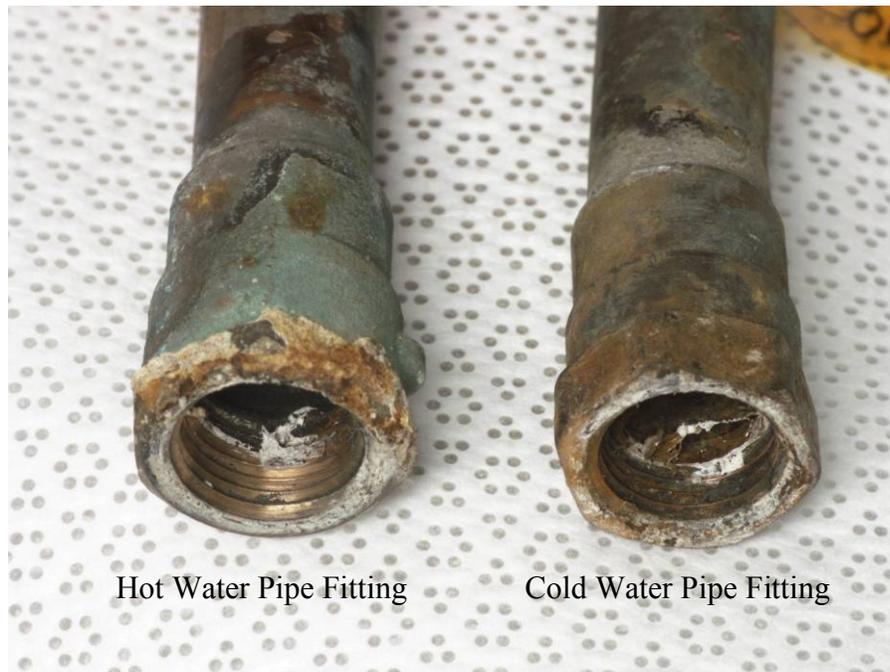
*Figure 3: Hot Water and Cold Water Pipe Fittings Removed from Building 5 Plumbing System.
Source: NASA Image.*
