Launching the *Vasa*

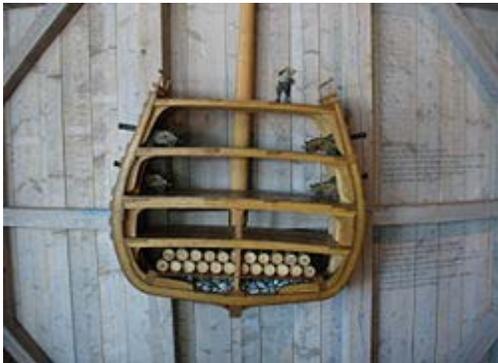
Figure 2 - Model of the Vasa's Hull Profile, Showing Shallow Keel and Two Gun Decks. Credit: Vasa Museum.

The shipbuilders added a fourth scarf to lengthen the keel, but the result was narrow in relation to its length and the draft very shallow for a ship of that size. A foot and a half was added to the beam, the widest part of a vessel, but because the keel, or backbone of the vessel, was already laid it had to be added to the uppermost parts of the ship. This raised the center of gravity and contributed to the ship's instability. The shallow keel did not allow sufficient room for the ballast needed to stabilize a ship of that size, and the narrow beam required extra bracing timbers, further reducing room for the ballast.

With a bigger ship, King Gustav demanded more—and bigger—guns, first insisting on 64 24-pounders, half on each deck, plus numerous smaller ones. Though it was built for 12-pounders, the upper deck now had to carry the added weight of 24-pounders, which further raised the center of gravity. In the end, the rushed schedule allowed for 48 24-pounders.
